Al-Mustaqbal University
College of Health and Medical Technologies
Radiological Techniques Department

Magnetic Resonance Imaging

First Semester Lecture 9,10 : Artifacts and their Compensation

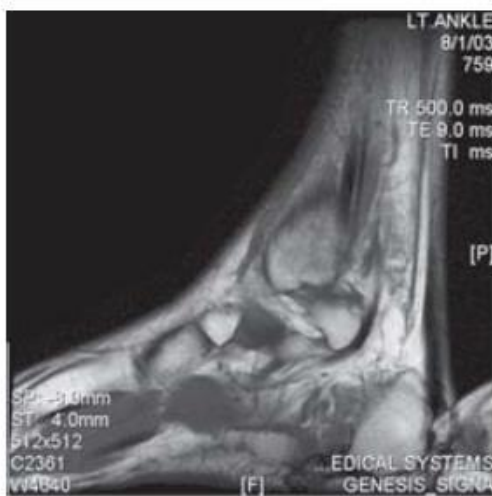
Fig. 7.3: Back folding artifact

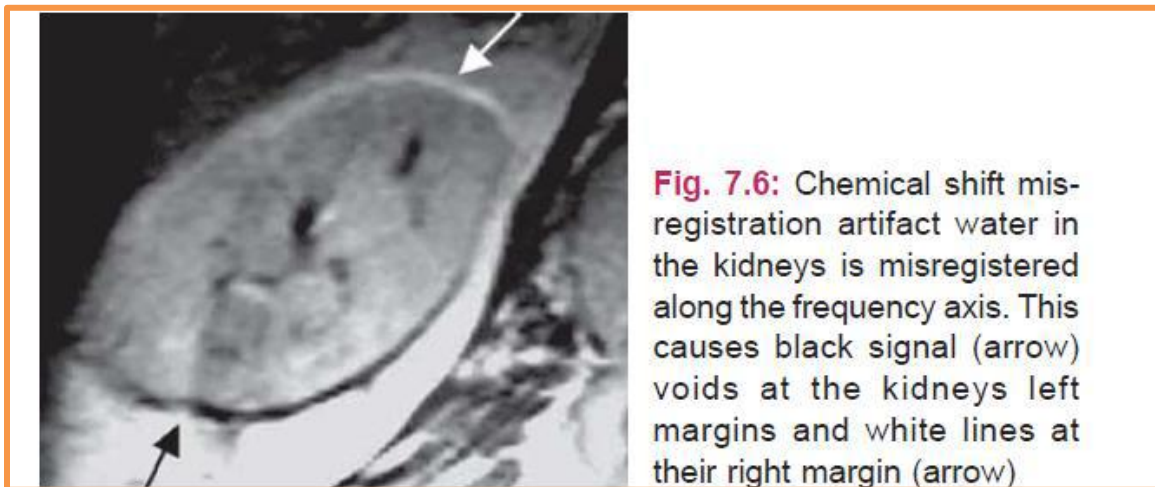
Chemical shift artifacts appear at the interfaces between water and fat because the precessional frequency of protons is slightly different in these two substances. This leads to misregistration of the signals. They are displayed by the equipment as dark region of signal void on one side of water containing tissue and a region of bright signal at the other end of the water fat interface due to super imposition of fat and water signals on the frequency encoding direction.

This artifact is greater at higher field strengths and can be reduced by increasing the bandwidth. **The only way to eliminate this artifact is to use a fat suppression technique.**

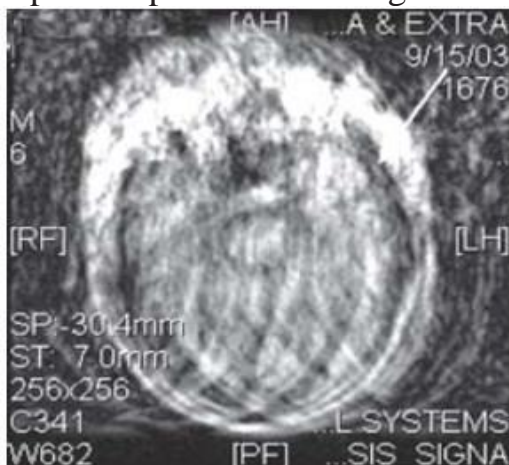
Fig. 7.9: Patient moving head. Axial section of the brain caused by motion of the head

Patient motion: Since all the images in one sequence are taken at the same time, it is important not to use excessively long sequences, as movement for a brief period spoils all the images.

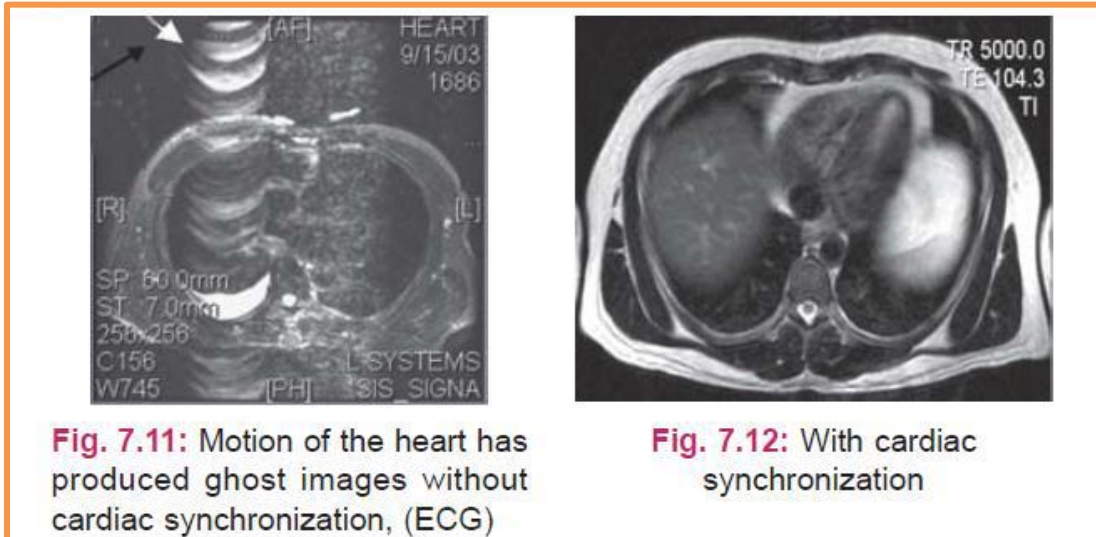
Cardiac motion: This type of artifact is caused by the contraction and relaxation of heart (chest) while the scanning is going on.

Remedy: To avoid this type of artifact, cardiac gating is mandatory during the procedure.

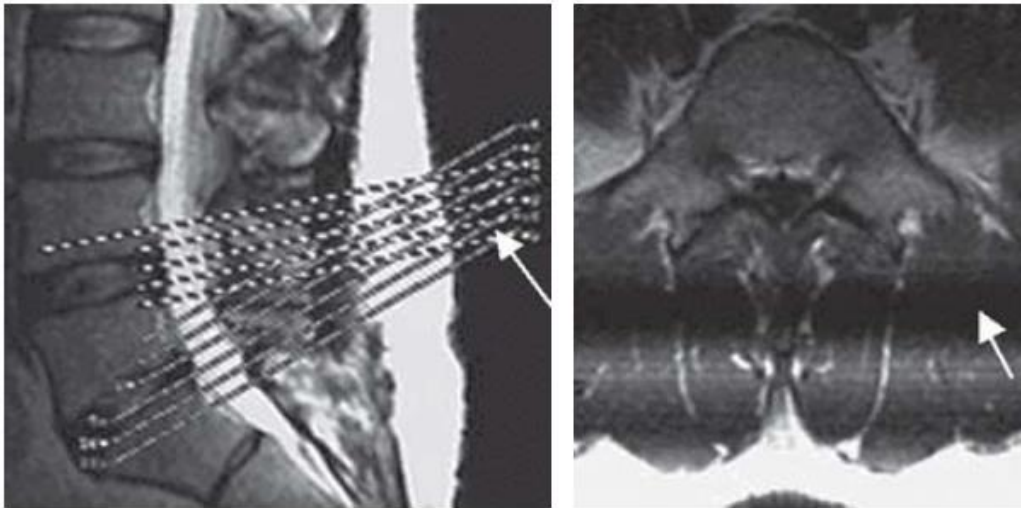
Arrow shows signal loss from overlap

Figs 7.22A and B: This is a para-axial T2 weighted image through L5/S1 from a multiangle, multislice acquisition, as is obtained commonly in the lumbar spine

If two levels are done at the same time, e.g. L4/L5 and L5/S1 then the level acquired second will include spins that have already been saturated. This causes a band of signal loss crossing horizontally or vertically in our image, usually prominent posteriorly.

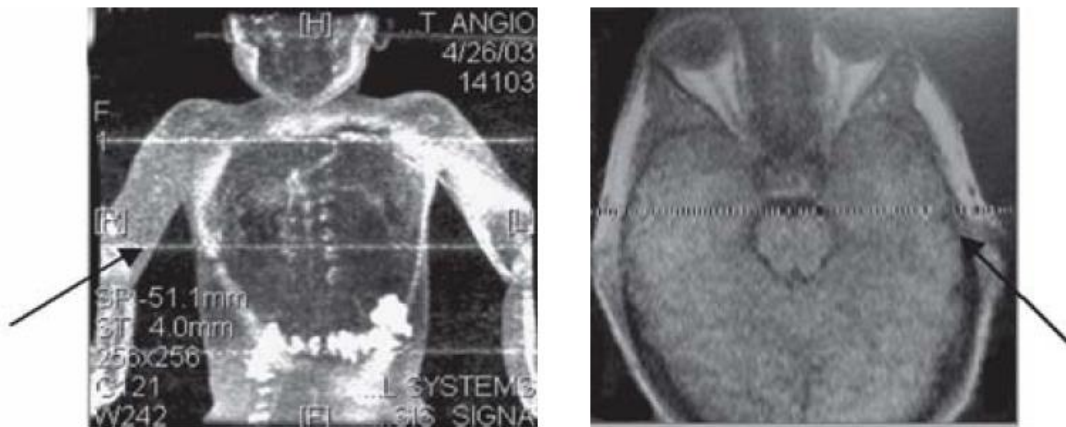
Figs 7.24A and B: Effect of right interface causing streak artifacts. This can be caused by a leaking RF, causing pick-up of external RF signals

This artifact is caused by external RF entering the room at a certain frequency and interfering with inherently weak signal coming from the patient. There are various causes for zipper artifacts in images. Most of them are related to hardware or software problems. The zipper artifacts that can be controlled easily are those due to RF entering the scanning room when the door is open during acquisition of images. RF from radio transmitters will cause zipper artifact that are oriented perpendicular to the frequency axis of the image. Frequently there is more than one artifact line on an image from this cause.
