1. CT artifacts: causes and reduction techniques

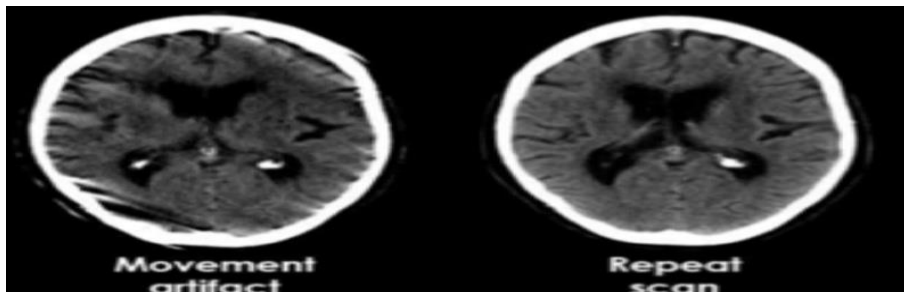
The image on the left shows the result of movement during scanning. The degraded image was repeated and no pathology was shown.

If a patient or structure moves as the gantry rotates the object will be detected as being in several positions and represented in the image as such.

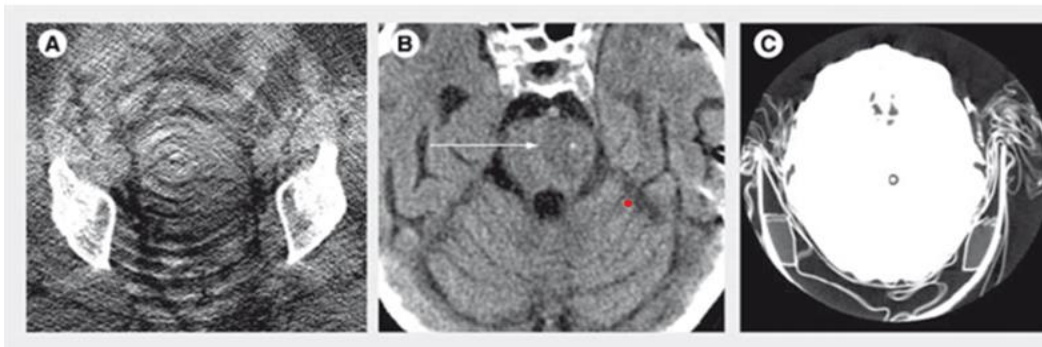
Ring artifact is caused by a miscalibrated or defective detector element, which results in rings centered on the center of rotation. This can often be fixed by recalibrating the detector.

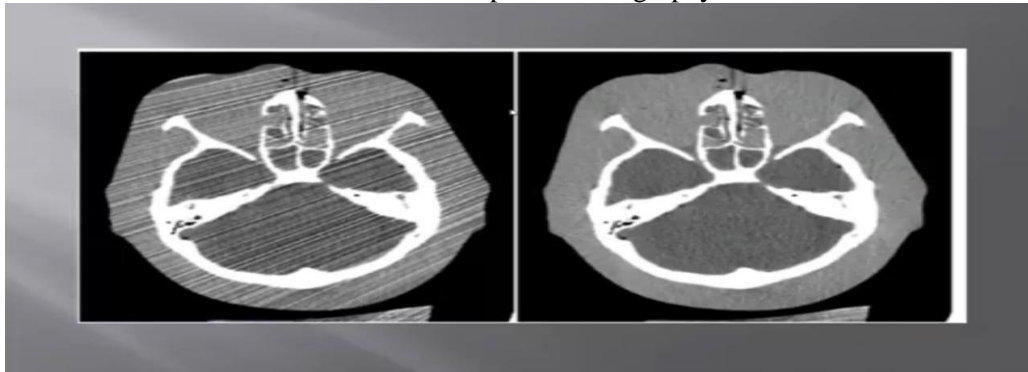
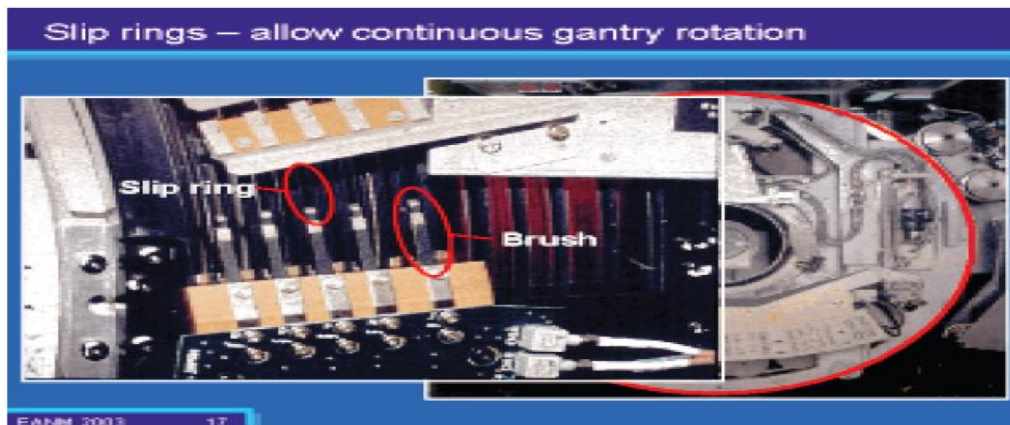
Tube arcing is known to be caused by a temporary short circuit in the x-ray tube causing momentary loss of x-ray output.
